TA-8179 CAM MAINSTREAMING CLIMATE RESILIENCE
INTO DEVELOPMENT PLANNING – PACAKGE A (45283-001)

*Advanced Vulnerability Assessment and
Adaptation Planning Training: Baseline
Assessment for Climate Resilient Feasibility
Studies in Urban, Transport and Rural
Infrastructure*

Date of training: September 26-28, 2016

Location: Kampong Chhnang Province, Cambodia

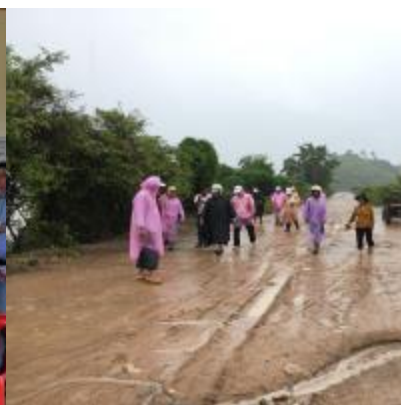
AWGs and authorities visit a submerged road in Da commune, Kampong Laeng District

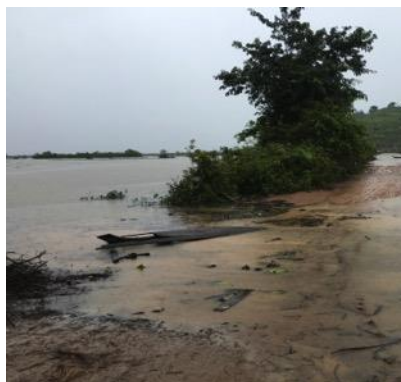
Segment of submerged road in Da commune, Kampong Laeng District

flooded forest land that flood during flooded season. This road is flooded during flooded season. People and students in Phlov Touk commune come to Kampong Laeng by boats. However, during water recession, travel by boat is also a big problem caused by floating water plant.

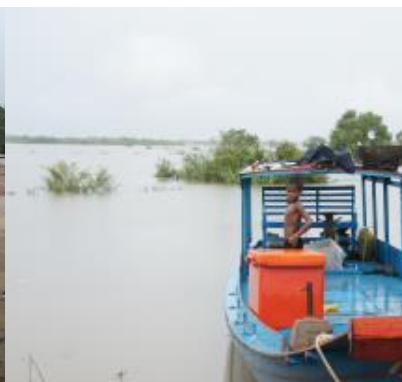
A mean of transport during the flooded season

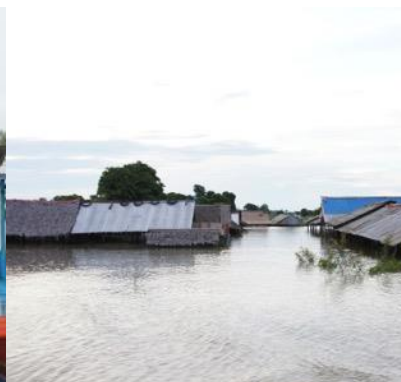
Local market submerged during the flooding season in Kampong Laeng district

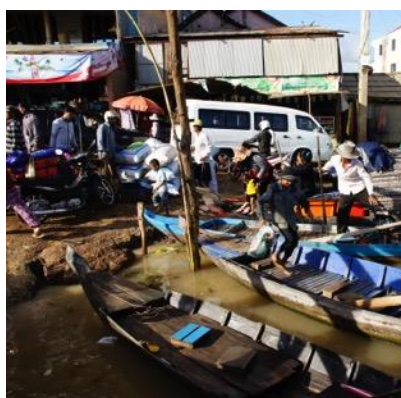
Market moved to mainland during flooding season in Kampong Laeng district

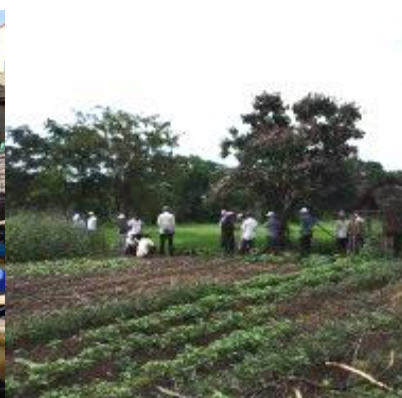
AWGs and relevant authorities visit Damrei Hel highland reservoir Chronok commune, Kampong Laeng District

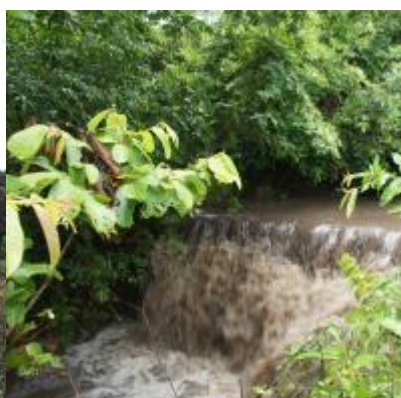
Water flows downstream from Damrei Hel highland reservoir Chronok commune, Kampong Laeng District

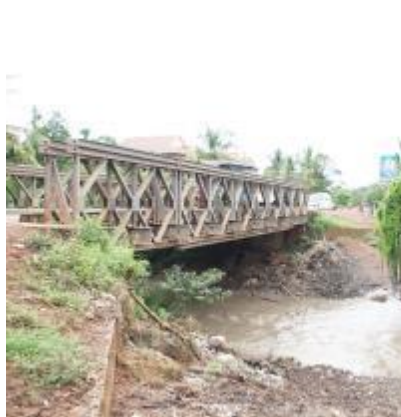
Water flows from Damrei Hel highland reservoir downstream across road 50C in Chronok commune, Kampong Laeng District

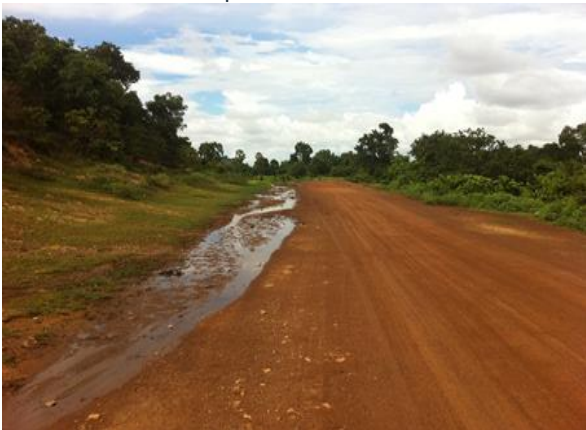
1. Main road (50C) around Touk Meas Mountain and associated infrastructure	Sub-components: E.g road surface, bridge culverts, ponds/reservoir, linked rural roads			
Sub-Component 1: Main Road 50C	<ul style="list-style-type: none"> Total length: 41.75Km Laterite paved: 31.95Km Bituminous paved: 9.80Km

<ul style="list-style-type: none"> Damaged by runoff and was flowed over, Critical damaged at Bale Bridge at Chronouk Commune, Insufficient structures, Road alignment is running around Touk Meas Mountain, 	<ul style="list-style-type: none"> by flash flowing from hill areas by increasing level water from Tonle Sap Bank, by group of castles crossing, by branch of tree was grow over the road surface, by insufficient structures to release discharge water, Lack of maintenance 	<ul style="list-style-type: none"> Provide land for Ox-Cart and Castles, Provide approach way at entrance or access roads, Cut the branch of tree where grow over the road surface, Add structure at necessary places, Cooperate with institutional skilled departments, Create the maintenance's communities,

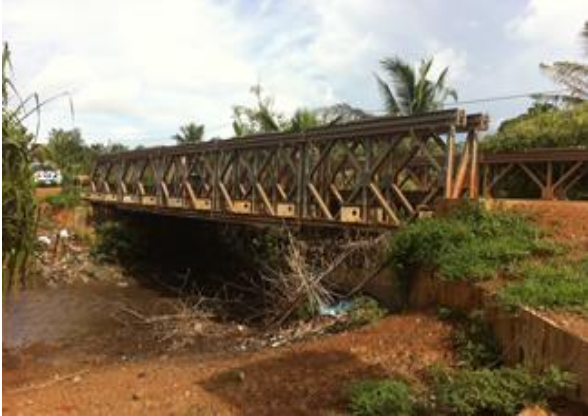
Sub-Component 2: Bale Bridge	<ul style="list-style-type: none"> Single span, Total Length: 18m, Width: 4m, Location: Ch. 25+500, Location: Chro Nauk Commune, Built: Military Engineering Unit, Year: 2003 	<ul style="list-style-type: none"> Flash flowing water from Domrey Hel reservoir, Scouring of bridge bottom, Erosion of the wingwalls, 	<ul style="list-style-type: none"> by flash flowing from mountainous area (Touk Meas), by flowing water from 	<ul style="list-style-type: none"> Stone pitching at the bottom of bridge, Extent wingwalls, Backfill and turfing at abutment slopes,

<ul style="list-style-type: none"> • Plenty of obstacle materials along the existing river, • Local truck with 4 axial load passing the bridge, 	<p>Domrey Hel reservoir due to no rehabilitation,</p> <ul style="list-style-type: none"> • by plenty of bush grow along the existing river, • Direction of flowing water is not perpendicular to bridge alignment, • Lack of maintenance 	<ul style="list-style-type: none"> • Plan the Reed, Romchek ... to protect erosion, • Routine maintenance or emergency maintenance is necessary, • Issue information to skilled department in case of broken some part of bridge,
Sub-Component 3: Pipe culverts	<p>Along the main road 50C, there are 86 places:</p> <ul style="list-style-type: none"> • Single rows $\phi 100$: 68 • Double rows $\phi 100$: 05 • Triple rows $\phi 100$: 09 • Box culvert (4mx2Span): 02 • Bridge (Bale & RCC): 02 	<ul style="list-style-type: none"> • Erosion at Up & Down streams, • Scorvering at Cut-off walls, • Pipe is filled by Silt & other obstacle materials, • A few pipes are unfunctional due to lack of maintenance, or by villagers fill soil at their land, • No clearing of existing canal at Up & Down streams, 	<ul style="list-style-type: none"> • by flash flowing from mountainous area (Touk Meas), • by backing up of water from downstream (Tonle Sap bank), • by filling soil, plantation from villagers, • Lack of maintenance • Lack of fund, 	<ul style="list-style-type: none"> • Back filling with proper compaction at erosions, • Using the stone pitching or Rip Rap to protect the flowing, • Extent wingwalls to protect side slope pressure, • Turfing at side slope to protect the erosion, • Clearing the silt or other obstacle item from pipe, • Repairing the cracking of concrete headwalls and wingwalls

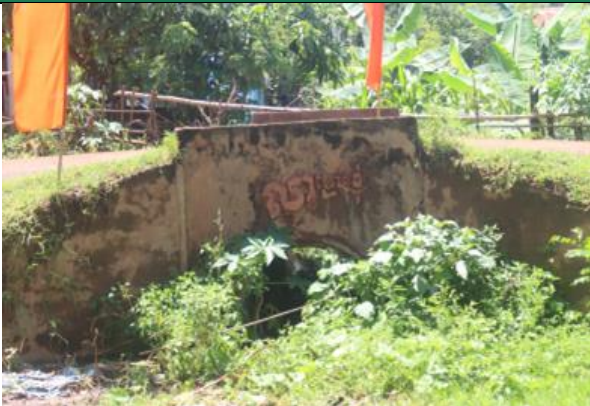
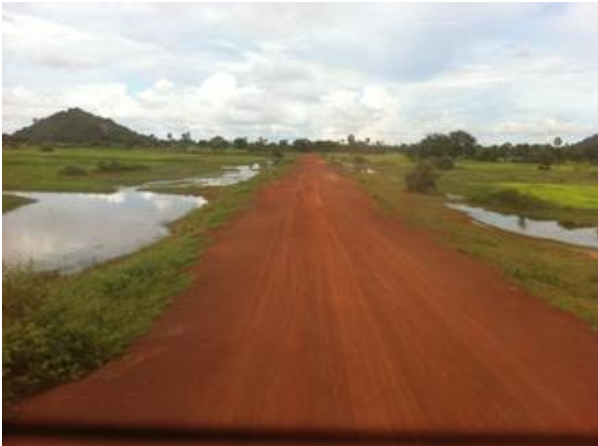
Sub-Component 4: Borrow pit	<ul style="list-style-type: none"> Side borrow pits and side drains are very important to drain the water out. Side borrow pits are a land use involving the excavation or digging of soil material for use as road embankment.

<ul style="list-style-type: none"> Unfunctional due to block of water way by bush and other obstacle materials, Silt up No proper shape of borrow pit or side drains, Type of soil is mostly sandy, Many access roads was constructed, Plenty of castles crossing the borrow pits, 	<ul style="list-style-type: none"> by flash flowing from mountainous area (Touk Meas), Type of soil is easily to erode and damage the shape, by group of castles crossing, 	<ul style="list-style-type: none"> Need to maintain by join from community, Debris and waste removal from side borrow pits, Using stone masonry at the critical erosion

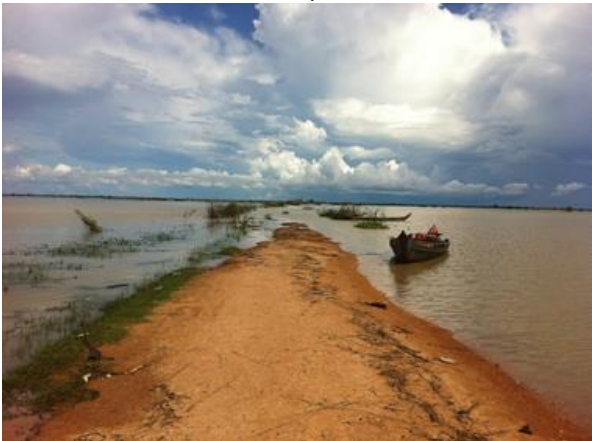
System components	Description of natural and manmade features and assets of the system	Condition Signs of degradation	Causes of degradation	Existing approaches to maintenance
Sub-Component 5: Samrong Sen Road	<ul style="list-style-type: none"> Road name: Dra-Samrong Sen Road length: is about 6Km Condition: 250m isn't affected by flood, other is submerged road, it is floodplain and unpaved, earth road was developed by community fund on 2013, HFL: max. 2.50m from rice field's elevation, Traffic: 6 months dry, 6 months flood

<ul style="list-style-type: none"> Back up water from Tonle Sap bank, Long time is under water (6 months), It is located on flat terrain 	<ul style="list-style-type: none"> by low elevation and unpaved road, by early traffic opening after water go down, 	<ul style="list-style-type: none"> Pave by using Concrete or Bitumen, Raise up the elevation by consider HFL, Adding structures with sufficient spans, Plant any kind of green engineering as grass, reed... to protect the erosion, Embankment and base use cement stabilizing,

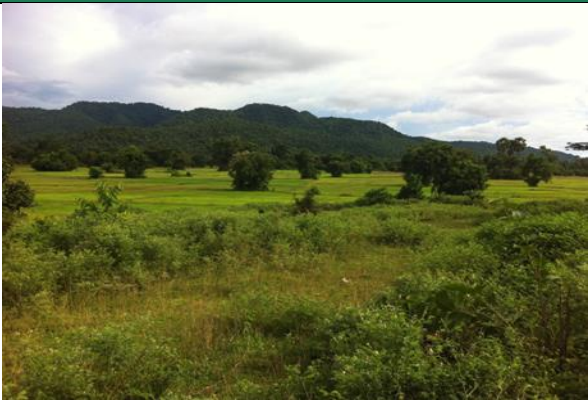
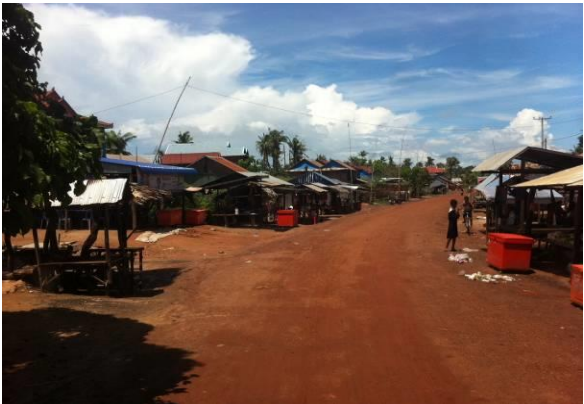
<ul style="list-style-type: none"> Using local recourse as rock, stone, aggregate, gravel...
Sub-Component 7: Rural Market	<ul style="list-style-type: none"> Location: along both sides of road 50C, Dar Village, Dar Commune, Number of Stalls: about 20 stalls permanently, Number of Basket: about 100 baskets Time: 3:00 AM – 7:00 AM Facility: No infrastructure, no garbage cans, no sanitation, no committee,

<ul style="list-style-type: none"> Mud & water Debris & waste Smell, Unpredictable accident by road users, 	<ul style="list-style-type: none"> by flowing water along road side drains, by improper management 	<ul style="list-style-type: none"> Move to the sufficient space with proper facility, Create the committee market user group, Find out the fund to develop the rural market

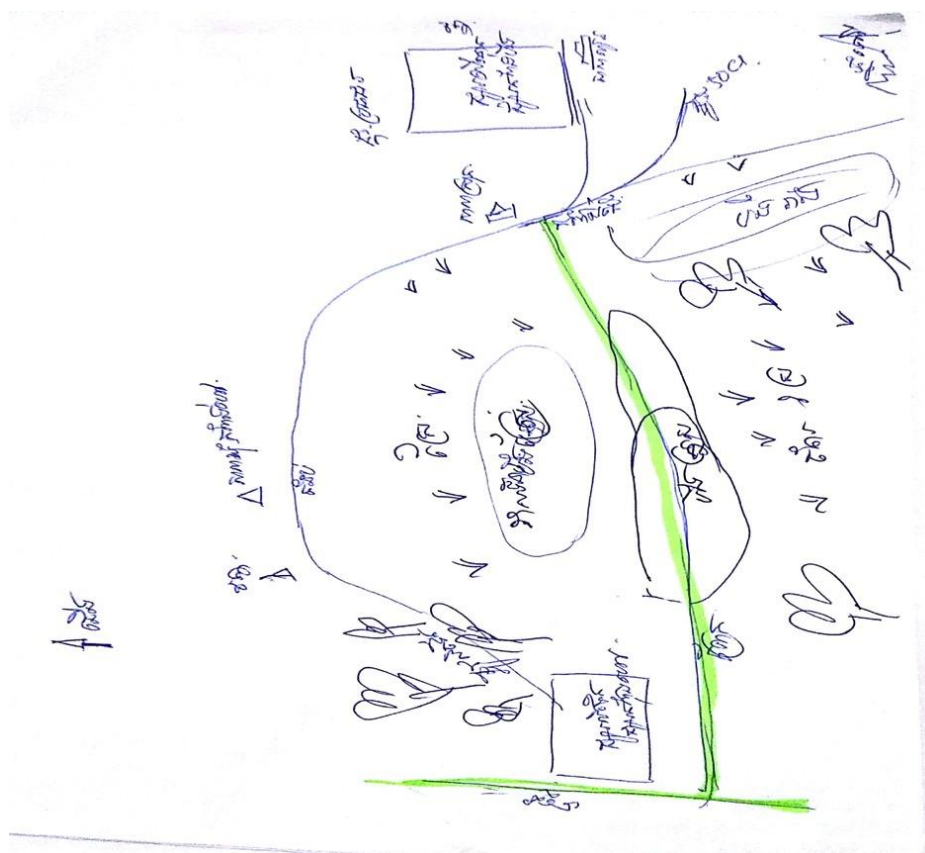
1. Draw the existing infrastructure system and surrounding landscape

This can be a rough sketch of the overall system showing key features and components. It can refer to photos you have taken, and show detail of any feature that you think is important. Use additional pages if needed.

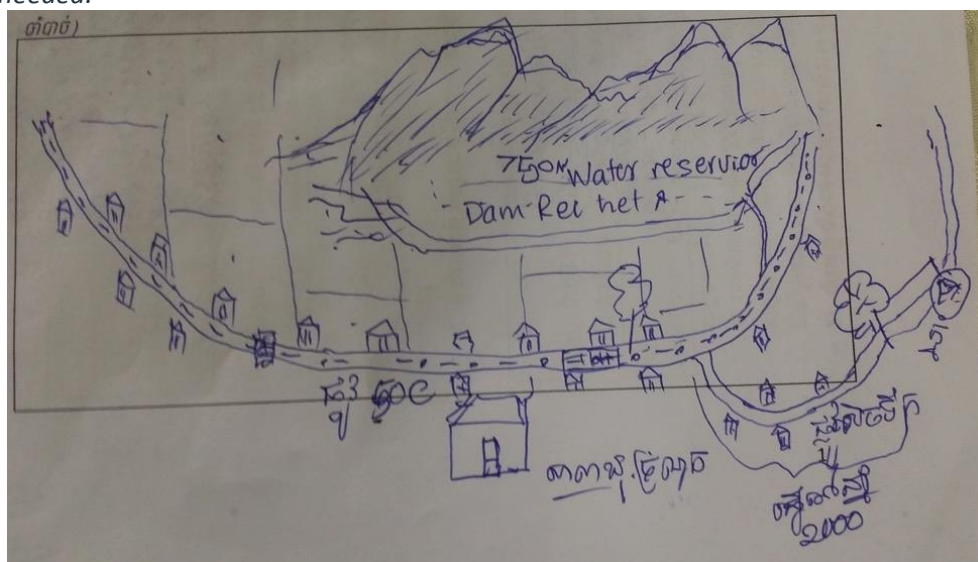
This drawing picture indicate geographical picture Chronok commune, connection between villagers' houses, road, mountains, agricultural field in commune. In direction from Da commune, Chronok commune is bear by cardamom mountain of Touk Meas at the left hand side of road 50C and low land/rice field at right hand side. Most of houses are located along both sides of main road 50C. This picture also presents connection between road 50C and Dam-Reservoir of Damrei Hel and submerged road from Chronok commune to Phlov Touk.
