TA-8179 CAM MAINSTREAMING CLIMATE RESILIENCE
INTO DEVELOPMENT PLANNING – PACAKGE A (45283-001)

*Scoping Vulnerability Assessment and
Adaptation Planning Training Workshop*

Date of training: November 18-20, 2015
Date of this record: November 25, 2015
Location: Battambang Province, Cambodia

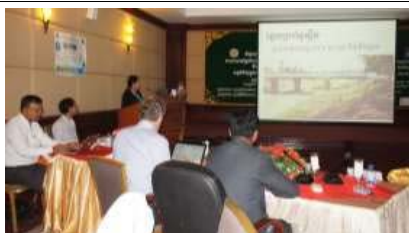
Site description and issues of riverbanks situated along Sang Ker River in Battambang city
